community Freedom
 address Elm Street
 county Carroll
 property name First Christian Church

survey no. FRE-C-1 FRE001
 owner name/address First Christian Church of Freedom, Freedom, N.H. 03836
 tax map/parcel no. map 52, lot 23
 USGS quad Freedom
 UTM zone 19 E 336180 N 4852950

survey no.: FRE-C-1
address: Elm Street, Freedom
property name: First Christian Church

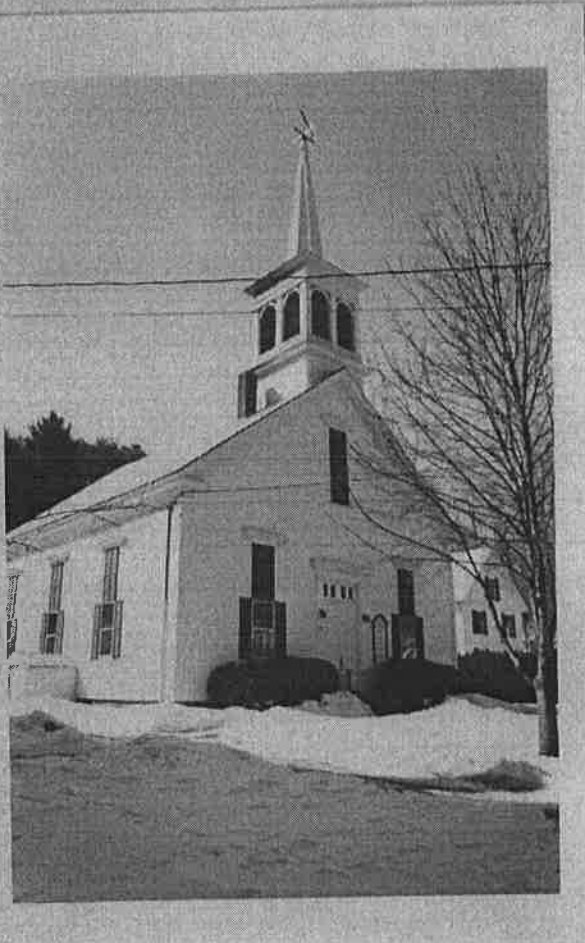
photographer facing: NW date: 3/14/89
 description of view: South and east facades of main block, belfry and basement vestibule.

condition (code) good
building integrity Save for vinyl siding and plastic shutters, exterior of main block appears unchanged.
site integrity Probably little changed.

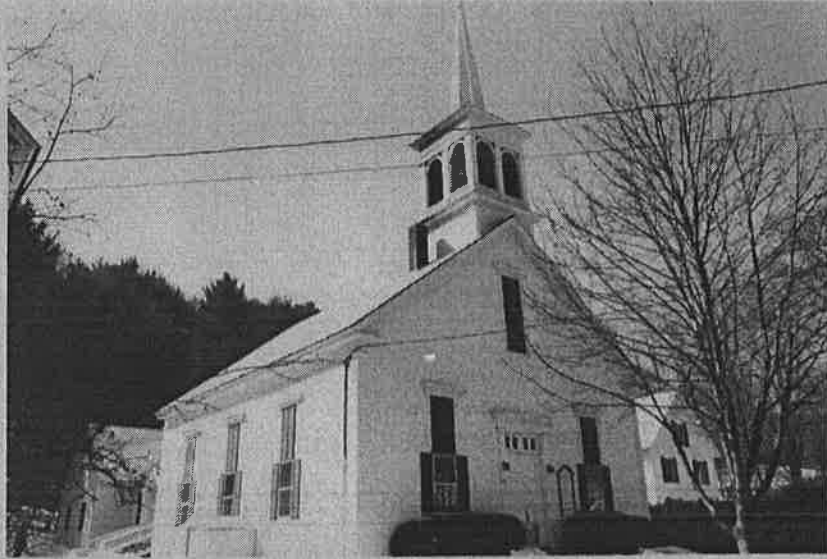
Photographer facing: Northwest Date: March 14, 1989
Description: South and east facades of rear wing, central wing, main block, basement vestibule and belfry.

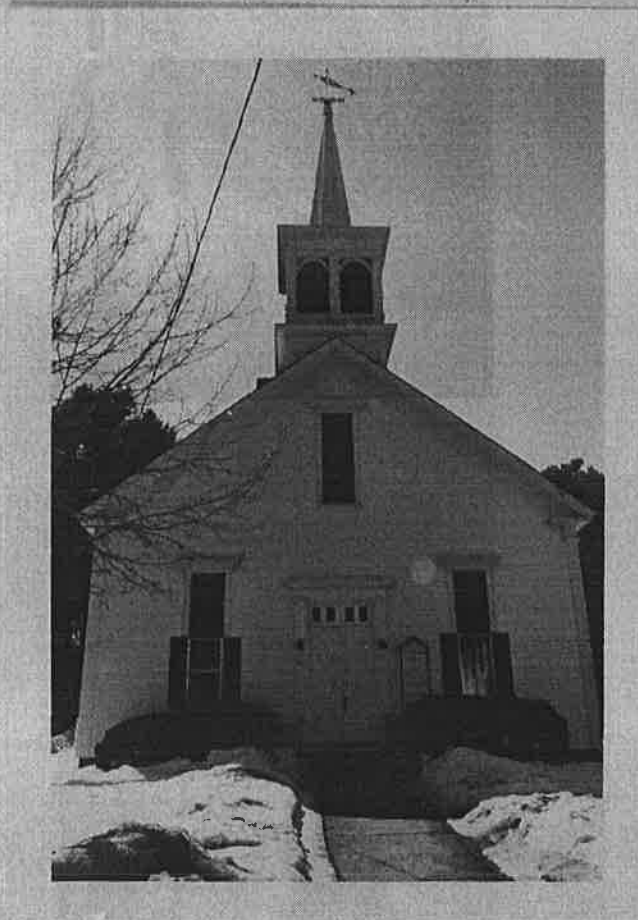
Photographer facing: West
Date: March 14, 1989
Description: East facades of main block and belfry.
