Town of Freedom

Town Office Feasibility Study

Masonic Temple & Town Office

29 & 33 Old Portland Road

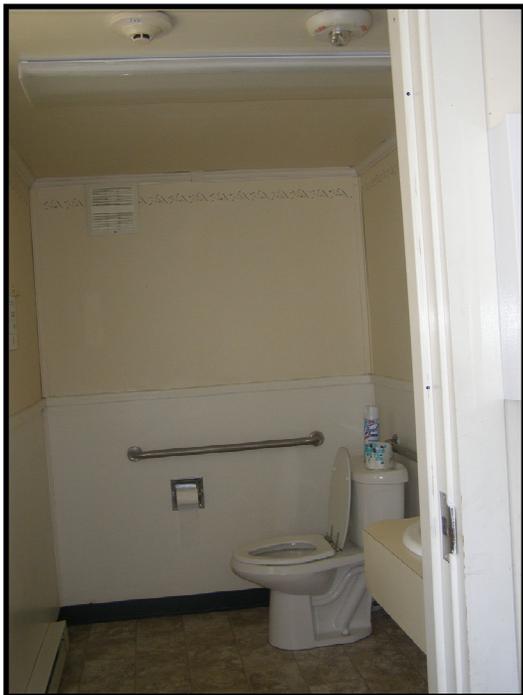
The restroom located on the first floor meets most accessibility requirements, though it is missing the required 18" vertical grab bar on the sidewall of the water closet (toilet).

Town Office Restroom. 18" vertical grab bar on the sidewall of the toilet required for accessibility is not installed.

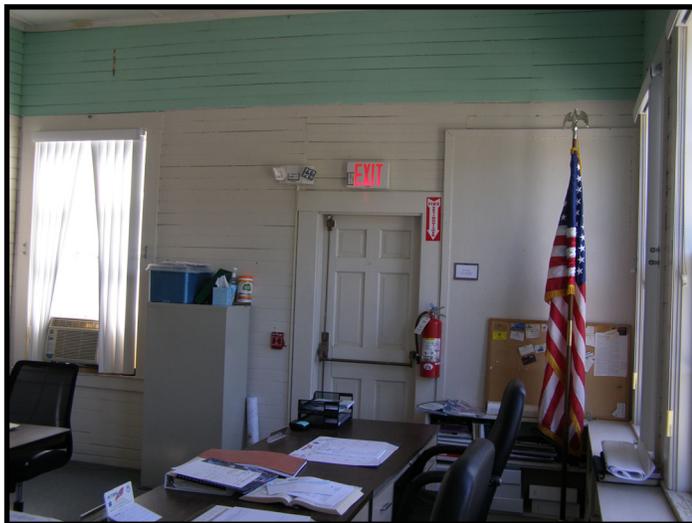
The exit from the second story is located on the easterly gable wall within the Selectmen's office, a wood door leading to an exterior steel fire escape stair. When we first went to open this door it was quite difficult to open from the interior and given the age and condition of the fire escape, we do not have confidence that the fire escape would be structurally sound enough to safely accommodate multiple people exiting the building at once. Additionally, exterior exit stairs are required to be (fire) protected from the interior of the building, and there are multiple unprotected window openings immediately adjacent to the fire escape stair. Should a window in the area of the fire escape become compromised, the fire escape stair would likely become unusable. The exit access from the second floor is by traveling down the existing interior stair, through the lobby and out the main entrance/exit of the building. This is recognized by the building and fire codes as an exit access and not an exit as the stairs are not fully enclosed and separated from the remainder of the building at both building levels and travel through the first story is required prior to reaching the exit itself. It was also noted that there is a metal duct serving the building's heating system installed within the stair's traveled way, along the interior wall. This duct has been wrapped in duct insulation, perhaps to prevent occupants from direct contact with the metal of the duct, however the duct projects into the required stair egress width, which is not permitted by the Life Safety Code.

Selectmen's Office looking at exit door to the exterior metal fire escape.

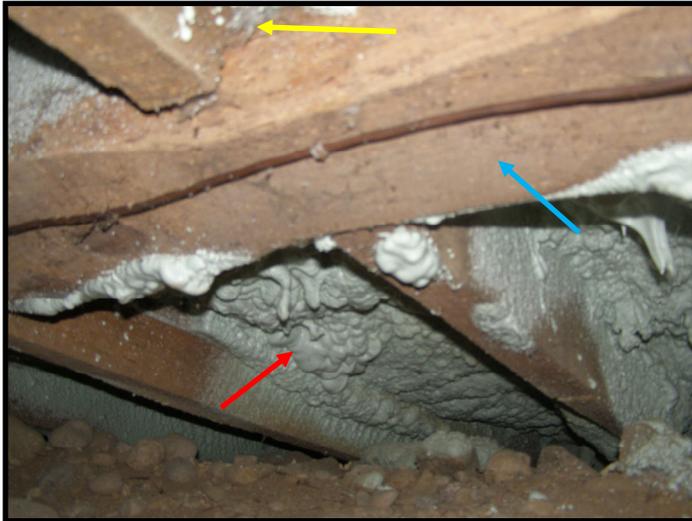
Photo of the first floor system taken from the crawl space. Blue arrow indicates a main carrying beam. The Yellow arrow indicates where the floor joists are 1/2 mortised into the beam. The red arrow indicates where approximately 6" of spray foam insulation has been installed between the floor joist bays.

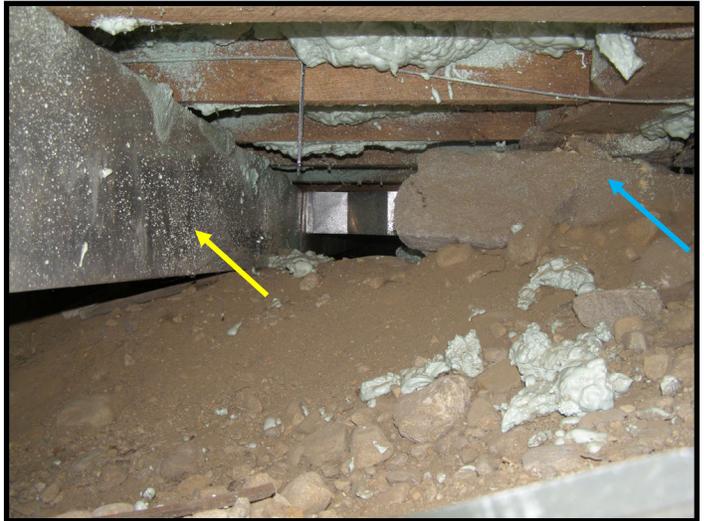
Photo of the first floor system taken from the crawl space. Blue arrow indicates a stone support. The yellow arrow indicates metal distribution ducting for the oil furnace.

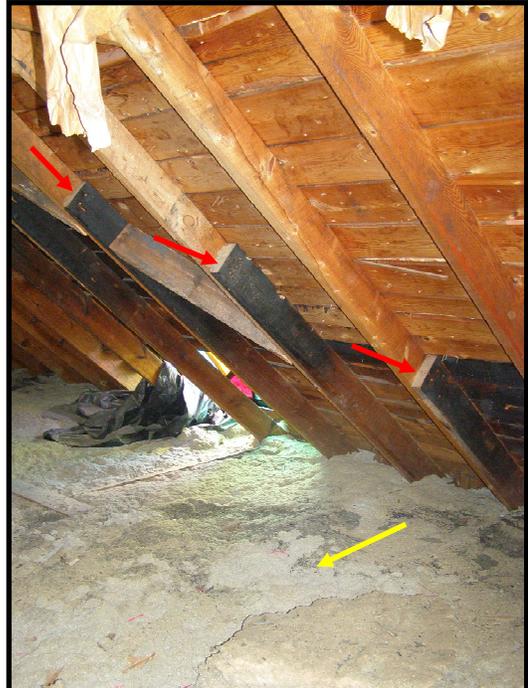
Photo of the attic. Red arrow indicates charred/cut rafters. Yellow arrow indicates blown-in cellulose insulation in the ceiling joist bays

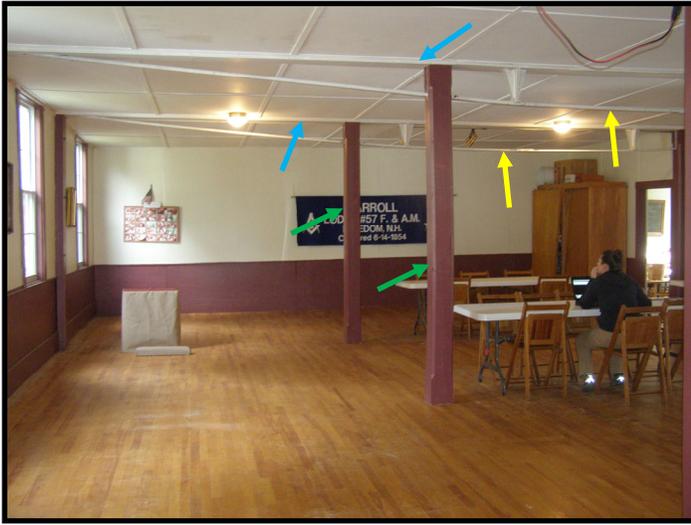
Existing banquet hall at first floor of Masonic Temple. Blue arrow indicates carrying beams for the second story floor. Green arrow indicates the mid-span columns supporting the floor beams. The yellow arrow indicates the steel tension rods.

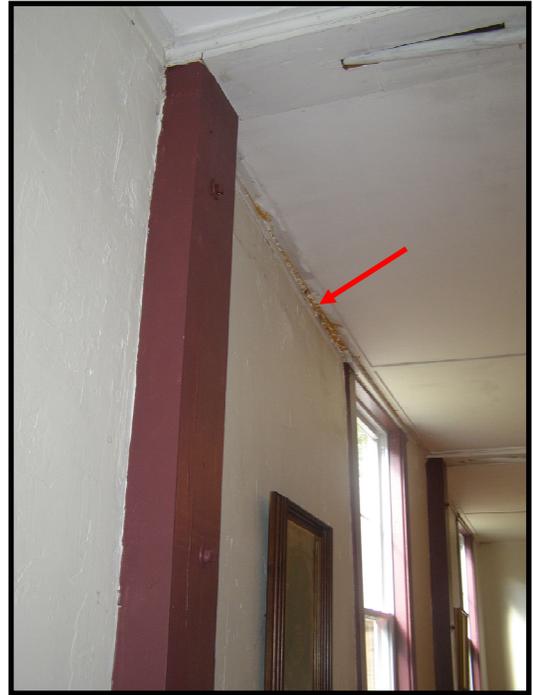
Westerly exterior wall of the Masonic Temple, viewed from inside the banquet hall. Signs of wall splaying can be observed at the wall-ceiling intersection.

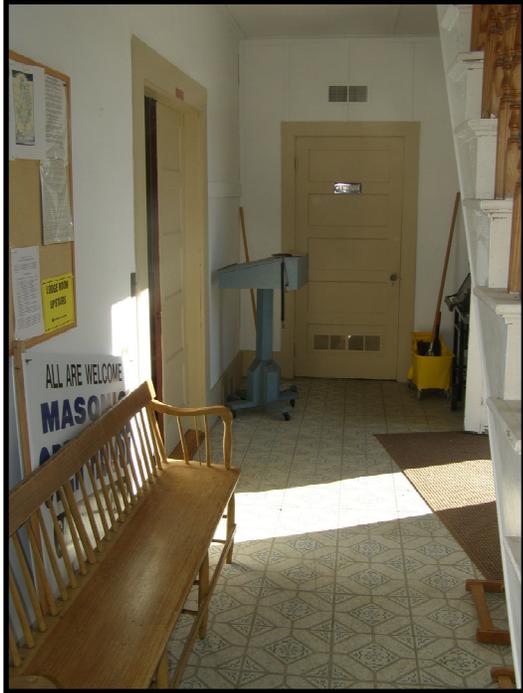
Masonic Temple first floor lobby, looking towards the east.
The tile floor in this space has tested positive for asbestos.

- The asbestos containing tiles at the Masonic Temple can be abated and replaced, encapsulated, or maintained to reduce the risk of asbestos fibers becoming airborne (regular waxing of the floor).

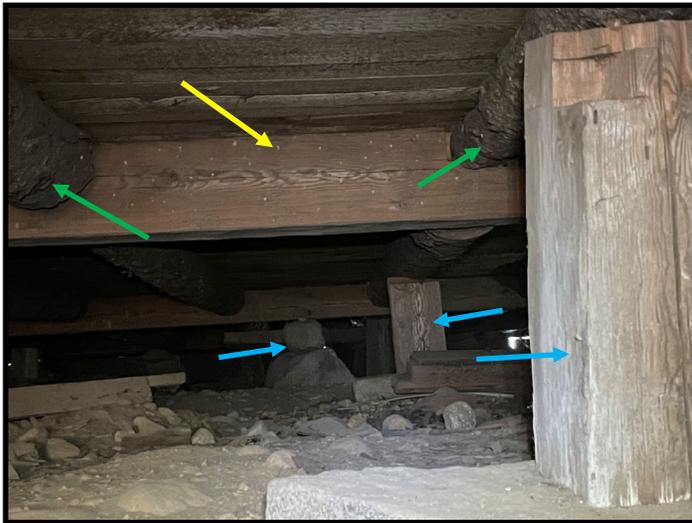
The first-floor system was inspected from within the crawl space under the building, accessed from an opening through the foundation wall of the north gable end. The first-floor system is constructed of wood members. There are three square milled beams that run the short axis of the building, east to west, spaced at equal intervals. Three-quarter (log) timber joists spaced approximately 3-feet on center span between the beams with the ends of the log joists bearing into mortises that were notched into the tops of the beams. There are multiple locations where original floor system members have been replaced or bolstered using various materials, mostly square milled timbers as either posts or intermediate beams. The floor is sheathed with 1" wood boards of various widths. The condition of the floor system appears sound, with adequate space between the soil and the underside of the wood members. Signs of powder post beetle presence was noted both in the wood members with frass located on the crawl space floor.

Masonic Temple crawl space/floor system. Yellow arrow indicates main carrying beam (with powder post beetle frass). Green arrow indicates 3/4 timber joists. Wood post and stone piers can be seen in this photo, supporting both beams and bolstering joists, (blue arrows).

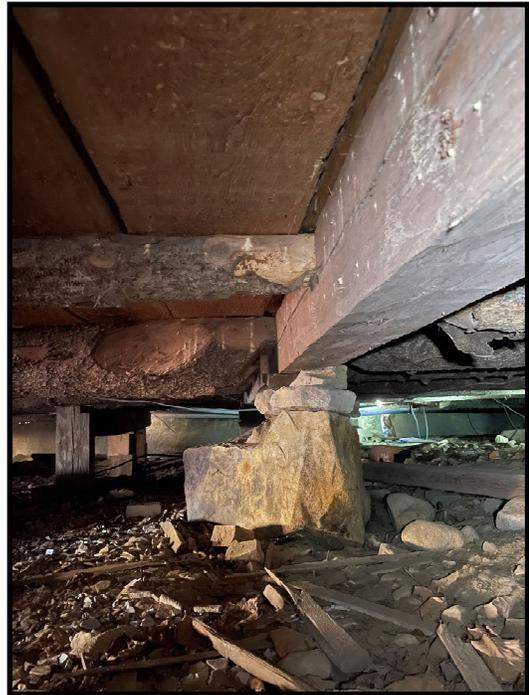
Side view of the timber joist connection to the main beams. The beam is supported by dry-stacked stones. Beyond, light can be seen coming through the granite perimeter foundation, where mortar has deteriorated and fallen away.

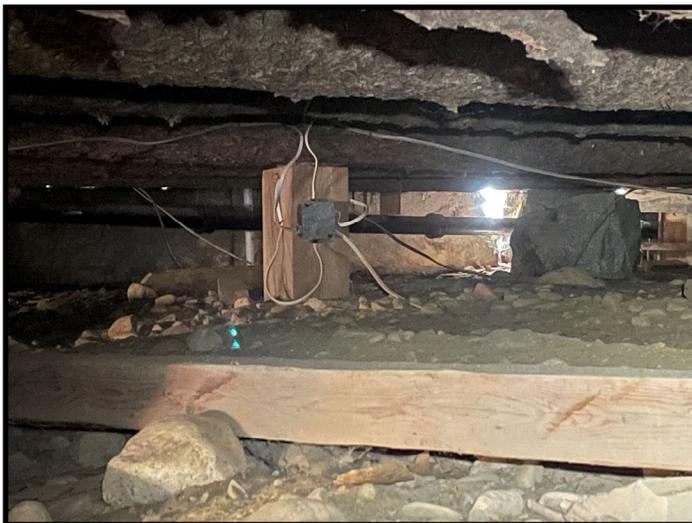
Masonic Temple crawl space/floor system. The condition of the crawl space is quite good, dry with sufficient space between the dirt floor and undersides of the wood floor members. This photo also shows an electrical junction box with exposed and unsupported non-metallic wiring.

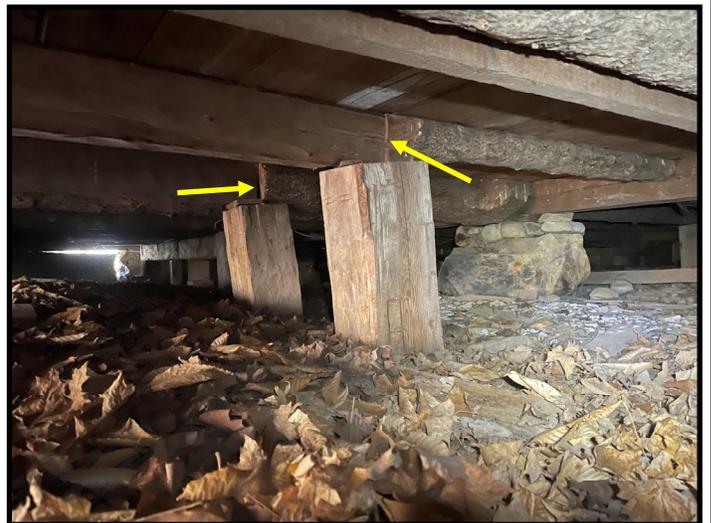
Masonic Temple crawl space/floor system. Yellow arrow indicates where timber joists have been cut/removed and replaced, with new wood posts installed at the joint. Wood posts have moved out of plumb, likely a result of seasonal movement over time.

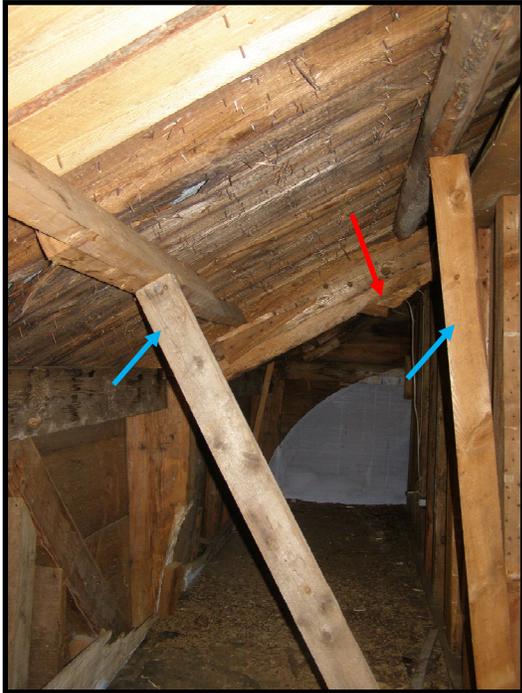
Westerly eave space at second story of Masonic Temple. Evidence of the original arched ceiling can be seen at the end (gable) wall. The original collar tie joint at a bent can also be observed (red arrow). This side of the roof remains sheathed in 1x boards. Additional dimensional lumber bracing has been added to support the roof purlins (blue arrow)

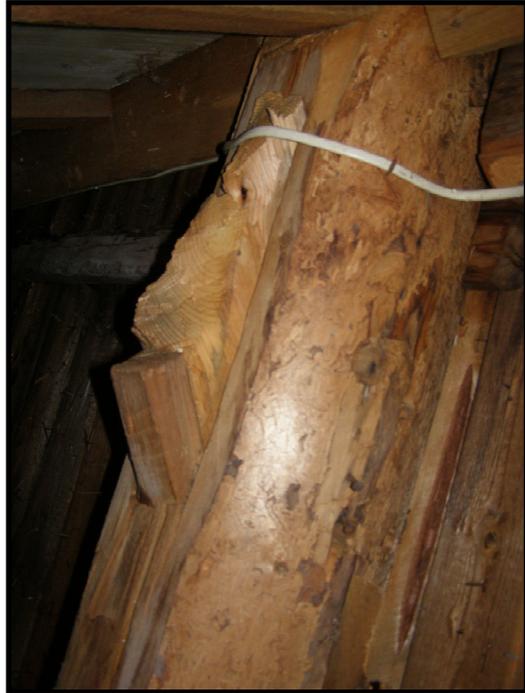
A close view of a joint where an original collar tie member was removed from the bent frame

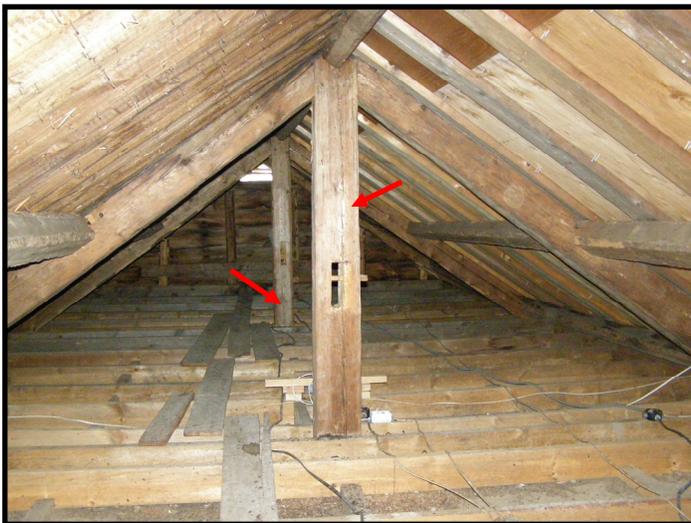
Attic space above second floor at the Masonic Temple. The king posts are indicated in red, these have been cut off the ceiling level, sandwiched and fastened between the 2x6 ceiling joists.

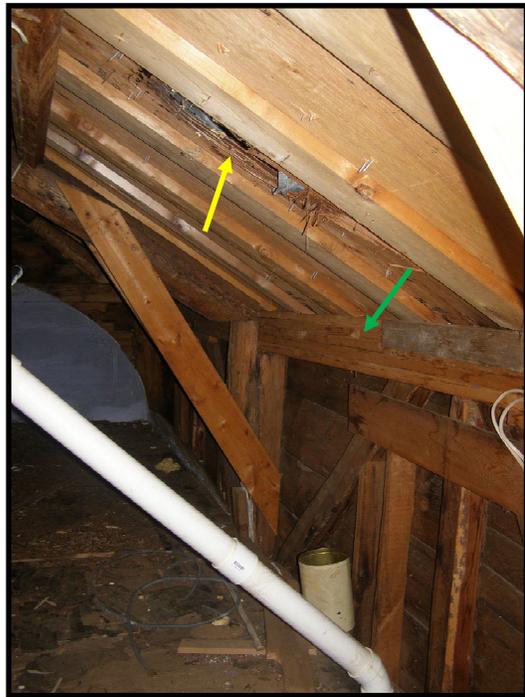
Easterly eave space at second story of Masonic Temple. The yellow arrow is indicating a hole in the OSB roof sheathing. Additional diagonal bracing has been added to the bent framing between the post and rafter. A section of the top plate has been replaced with dimensional lumber (green arrow).

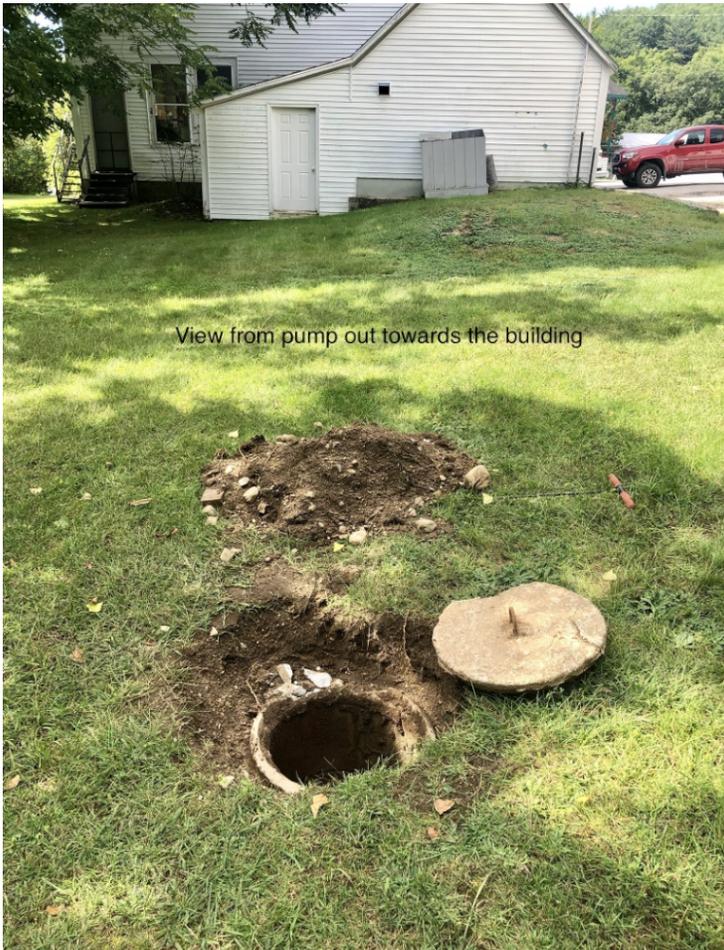
septic system appears in working condition. septic tank was pumped prior to inspection, so system could not be loaded for perc test.

trees in/above leach field should be removed, and Root Kill applied

View from pump out towards the building

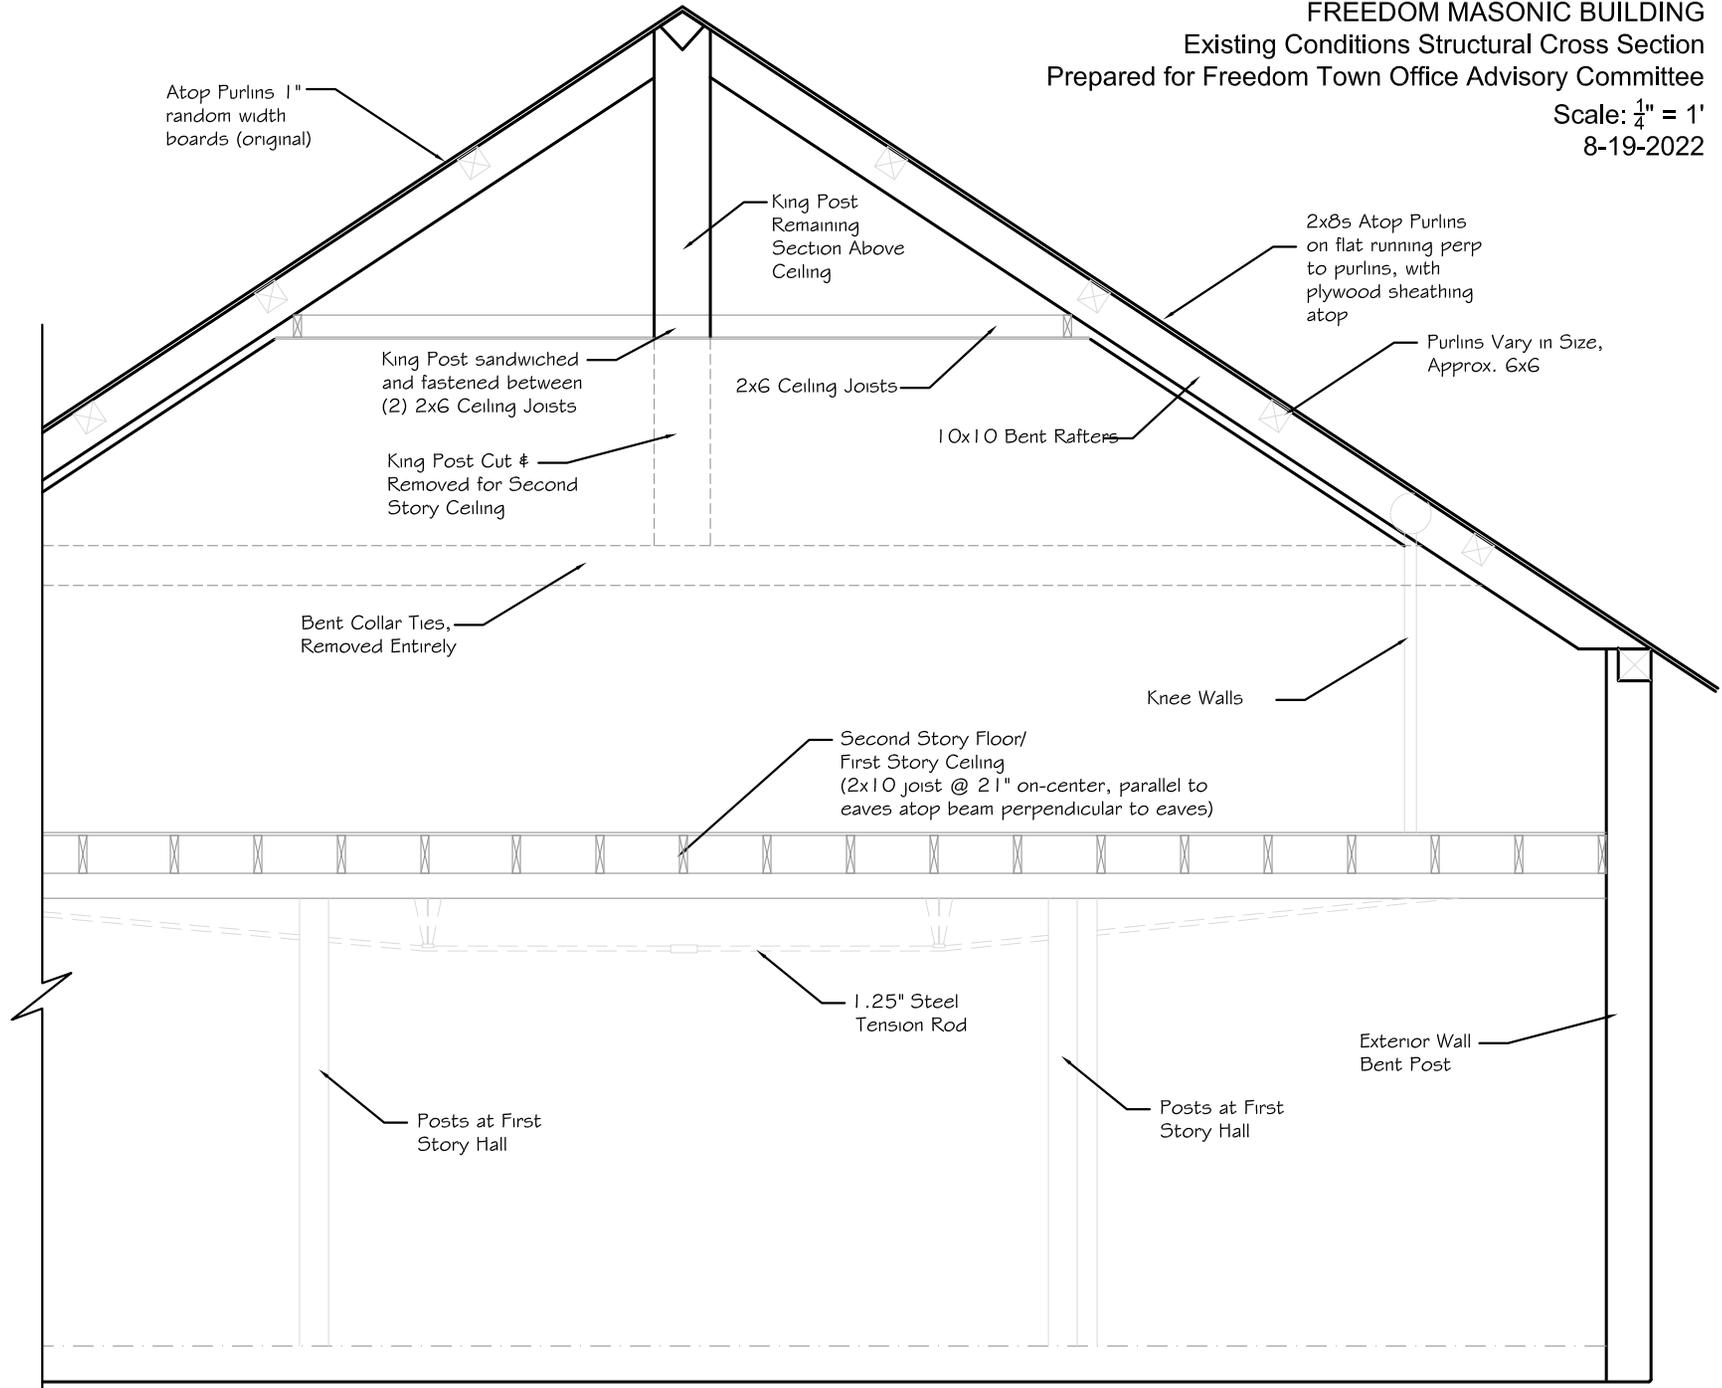
Cross Section View Looking To North Gable Wall

FREEDOM MASONIC BUILDING
Existing Conditions Structural Cross Section
 Prepared for Freedom Town Office Advisory Committee
 Scale: $\frac{1}{4}'' = 1'$
 8-19-2022
