Long-Term Variable Milfoil Management Plan

*Danforth Pond System
Freedom, New Hampshire*

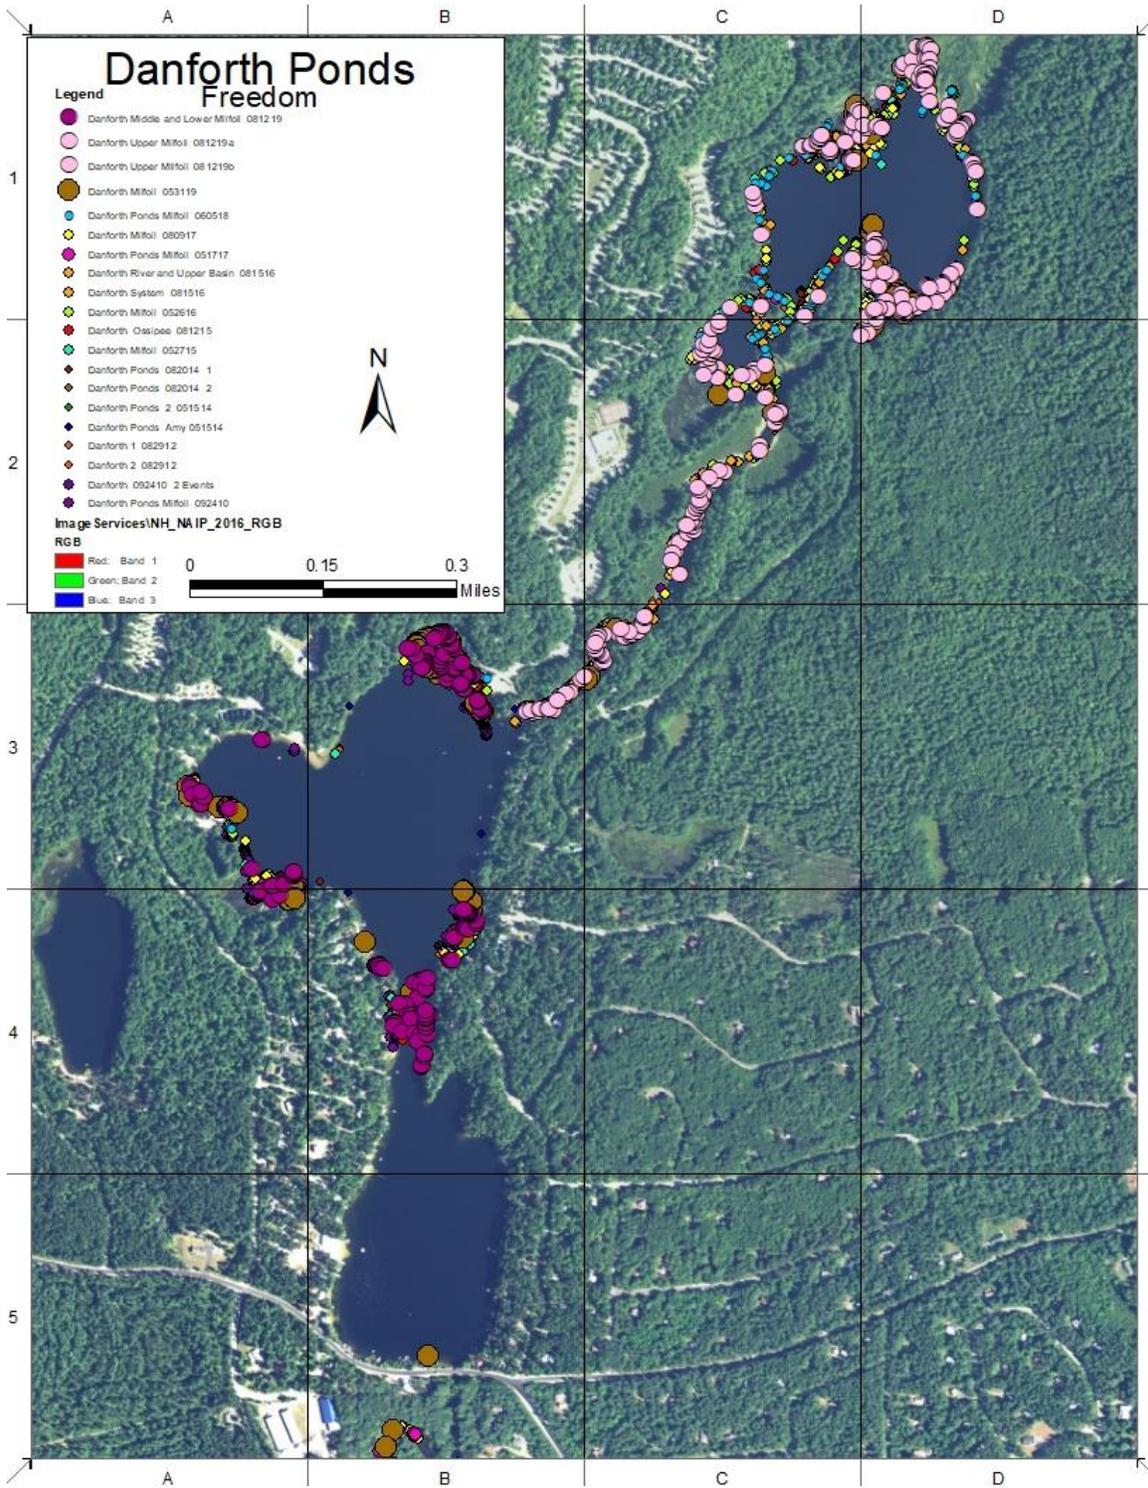
Figure 1: Map of Variable Milfoil Infestations Over Time

Figure 1 illustrates the distribution of variable milfoil infestations in this waterbody over time, with general area labels shown on the map for ease of reference. Figure 2 illustrates, over several maps, the sequence of exotic plant control actions over time, including one for the upcoming growing season.

The following table provides a summary of each area indicated in Figure 1, based on updated data from each year (as available) at the end of the growing season. Note that infestations prior to 2009 did not involve detailed mapping or record keeping.

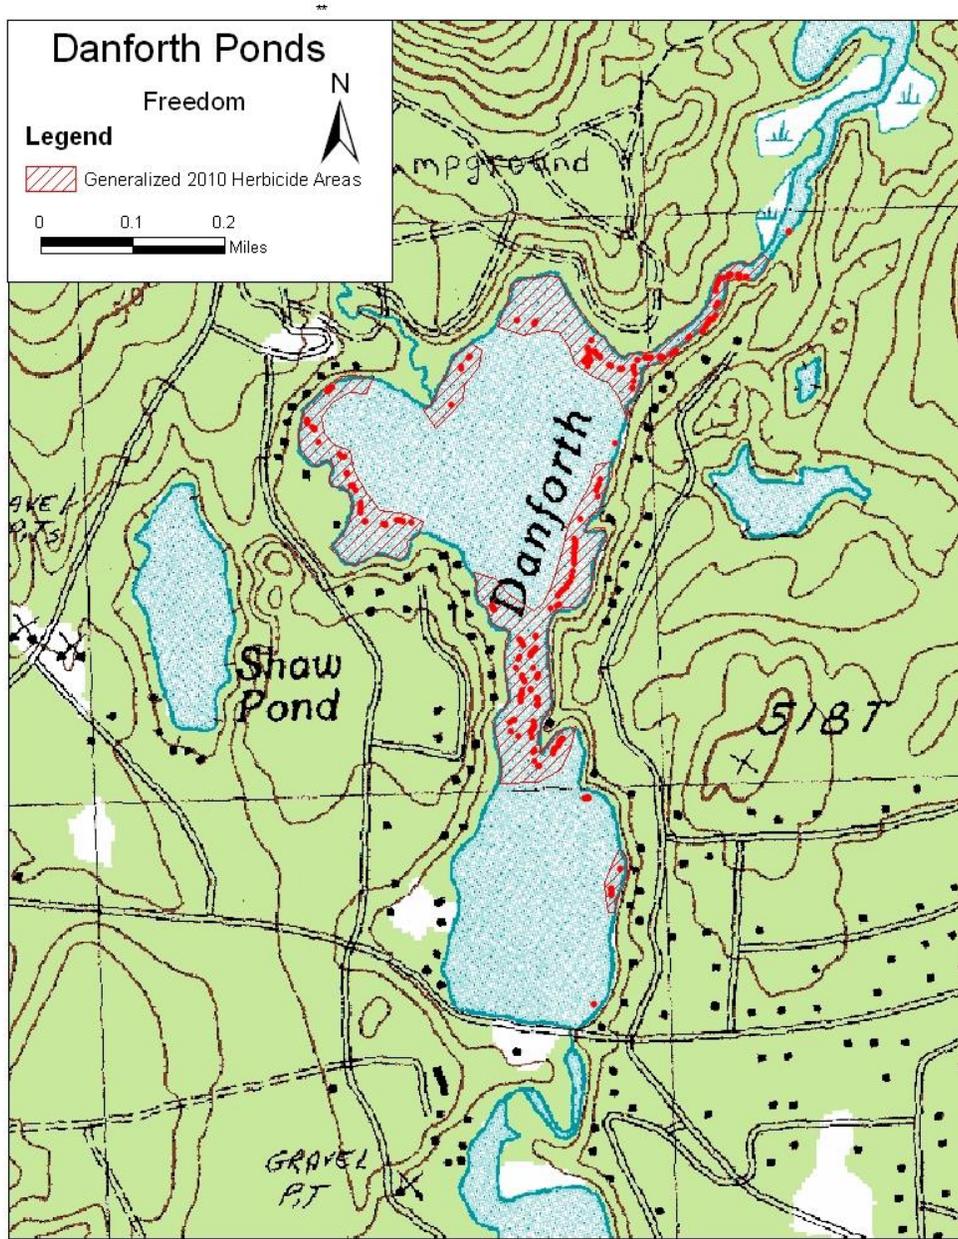
2010

Figure 2: Map of Control Actions Over Time

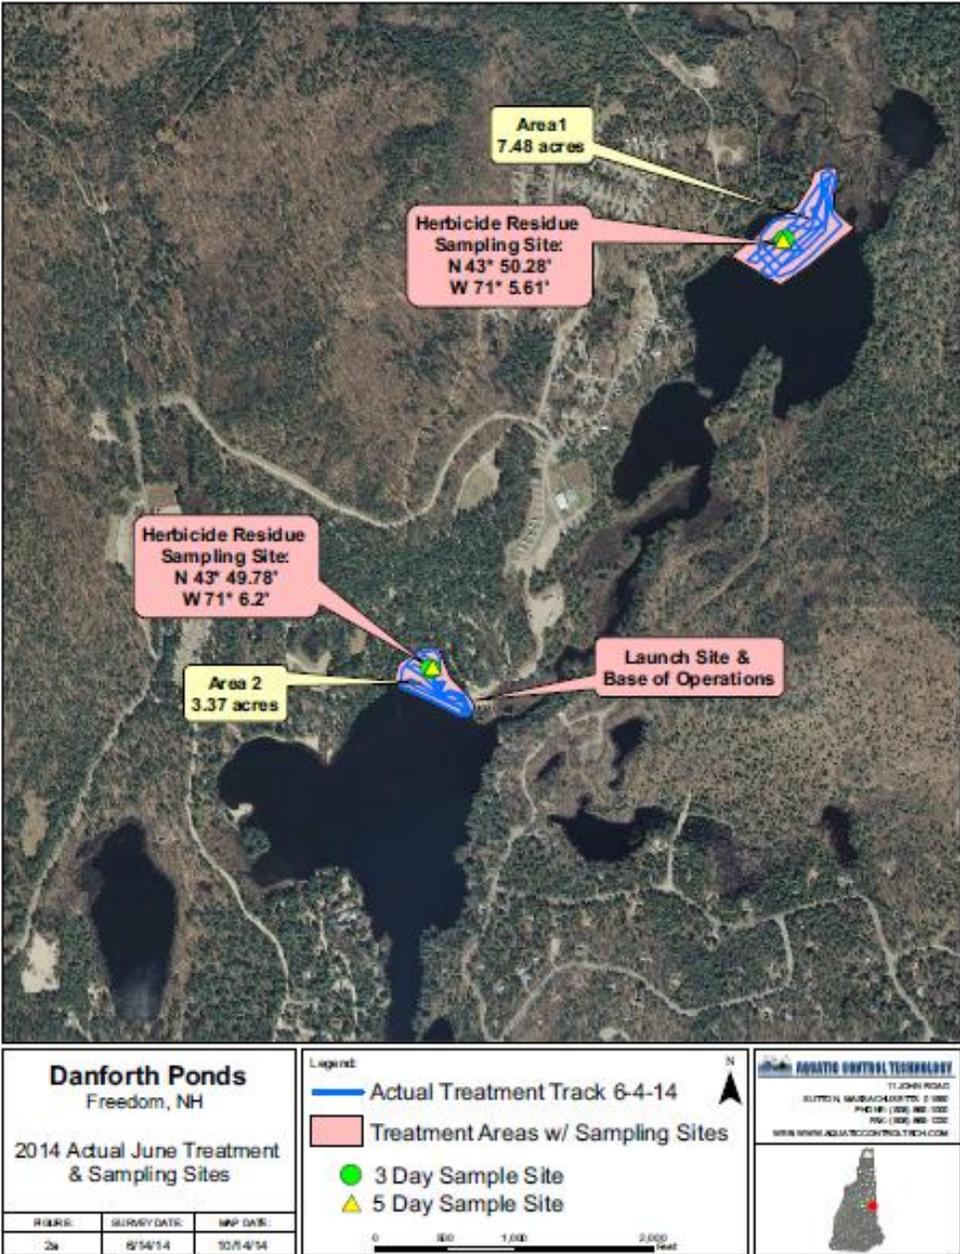
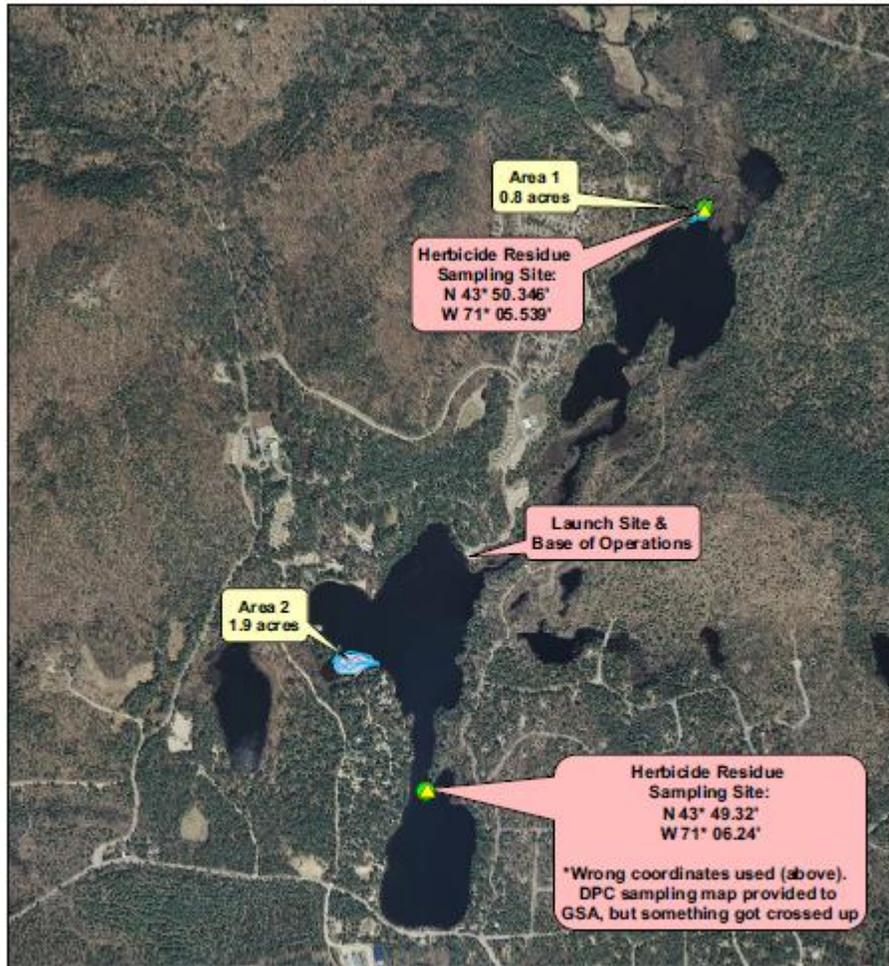
2014 (Actual)

<p>Danforth Ponds Freedom, NH</p> <p>2014 Actual Fall Treatment Track & Sampling Sites</p>			<p>Legend:</p> <ul style="list-style-type: none"> — Actual Treatment Track 9-11-14 Treatment Areas w/ Sampling Sites ● 10 Day Sample Site ▲ 20 Day Sample Site <p>0 700 1400 2800</p>	<p>AQUATIC CONTROL TECHNOLOGY</p> <p>11 JONES ROAD SUTTON, MASSACHUSETTS 01550 PH: (508) 868-1332 FAX: (508) 868-1332 WWW.AQUATICCONTROLTECH.COM</p>
<p>ROWS: 2</p>	<p>SURVEY DATE: 2014</p>	<p>MAP DATE: 10/15/14</p>

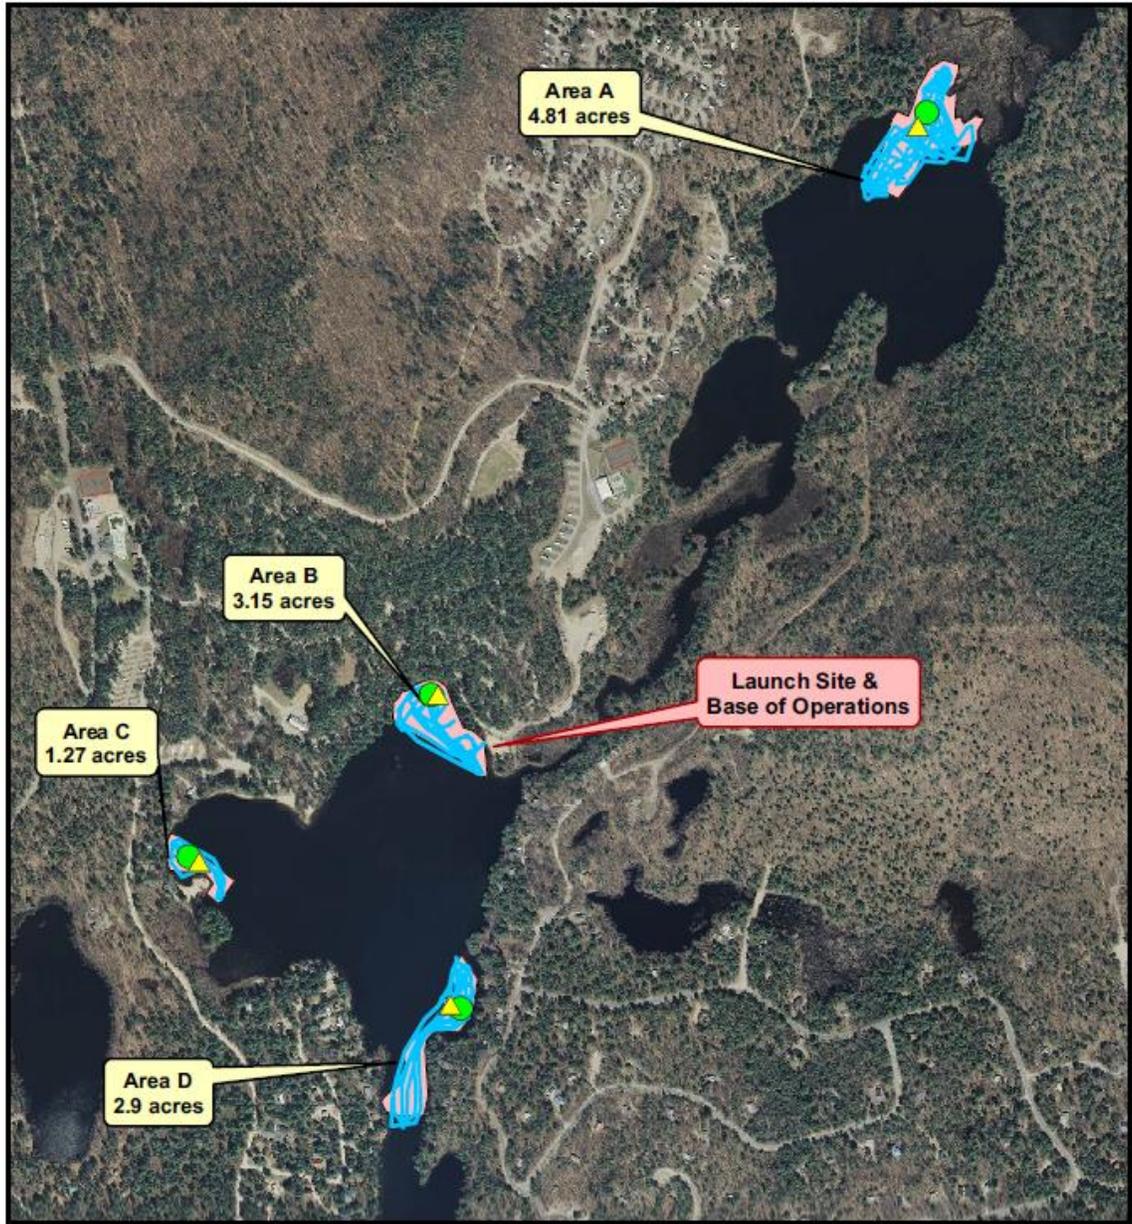
2015 (Actual)

<p>Danforth Ponds Freedom, NH</p> <p>2015 Spring Actual Treatment / Sampling Areas</p>			<p>Legend:</p> <ul style="list-style-type: none"> Spring Treatment Areas (12.13 acres) Actual Treatment Path (6/18/15)) 10 Day Sampling Location 20 Day Sampling Location 	<p>N</p>	<p>AQUATIC CONTROL TECHNOLOGY 21 WEST MAIN STREET SPENCER, MASSACHUSETTS 01562 PHONE: (508) 885-0101 WWW.AQUATICCONTROLTECH.COM</p>		
<table border="1" style="width: 100%; border-collapse: collapse;"> <thead> <tr> <th style="text-align: left; font-size: 8px;">FIGURE</th> <th style="text-align: left; font-size: 8px;">SURVEY DATE</th> <th style="text-align: left; font-size: 8px;">MAP DATE</th> </tr> </thead> <tbody> <tr> <td style="text-align: center;">2</td> <td style="text-align: center;">6/18/15</td> <td style="text-align: center;">10/9/15</td> </tr> </tbody> </table>	FIGURE	SURVEY DATE				MAP DATE	2
FIGURE	SURVEY DATE	MAP DATE					
2	6/18/15	10/9/15

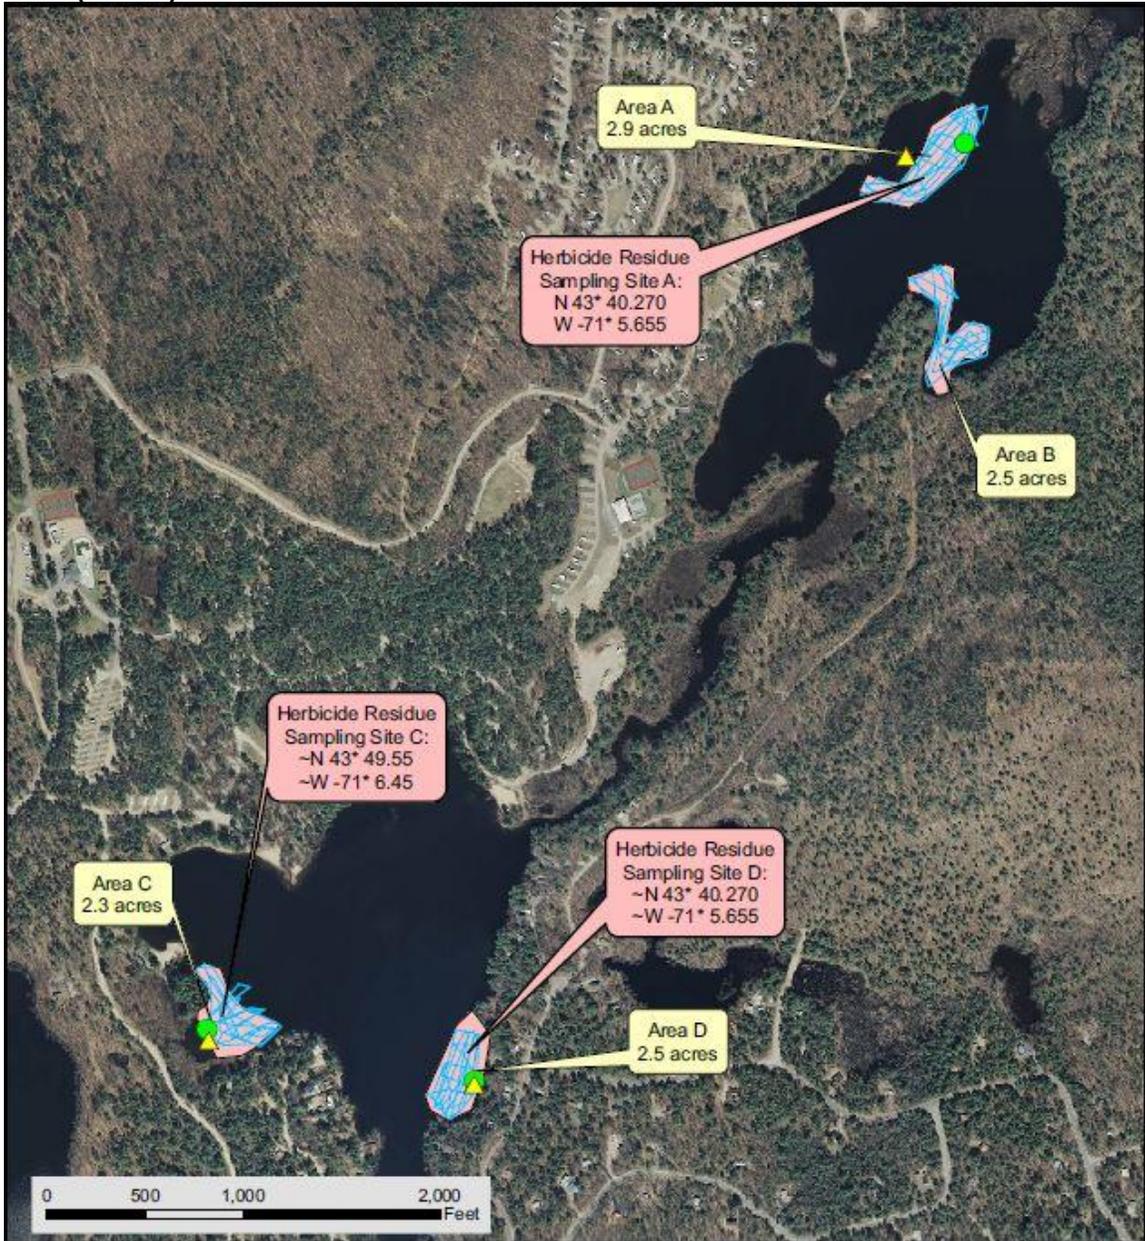
2017 (Actual)

2017 Actual Treatment & Sampling Map

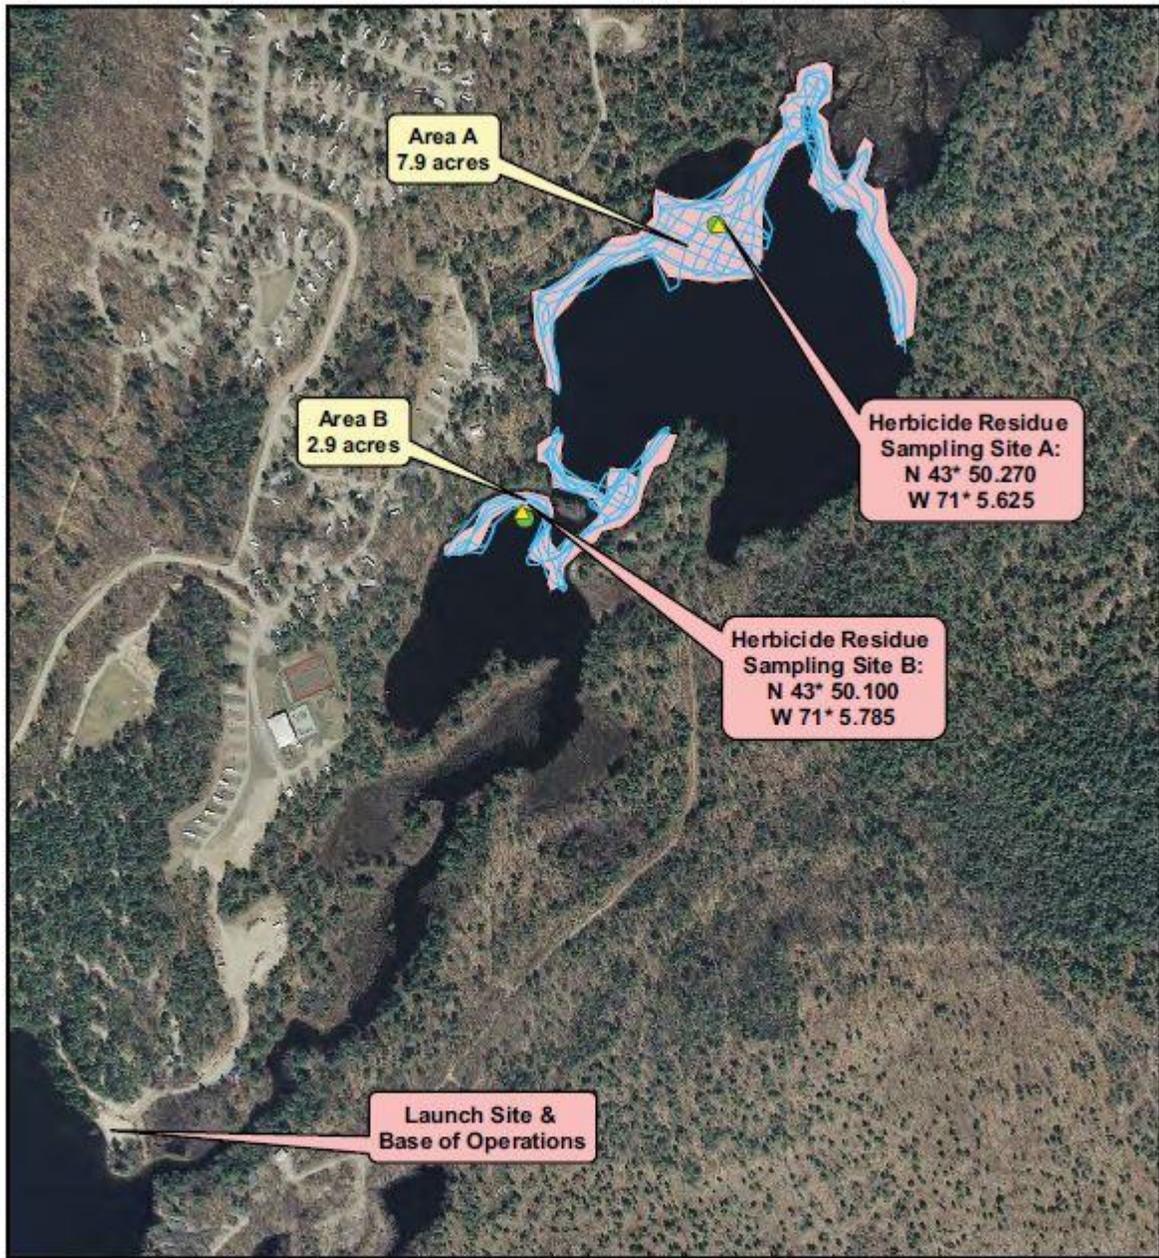
2018 (Actual)

<p>Danforth Ponds Freedom, NH</p> <p>2018 Actual July Treatment & Sampling Map</p>			<p>Legend:</p> <ul style="list-style-type: none"> July Treatment Areas (10.8 acres) Actual Treatment Track (7/11/18) 10 Day Sampling Location 20 Day Sampling Location <p style="text-align: center;">0 300 600 1,200 Feet</p>	<p>SOLITUDE LAKE MANAGEMENT 590 LAKE STREET SHREWSBURY, MA 01545 PHONE: (508) 865-1000 SOLITUDELAKEMANAGEMENT.COM</p>

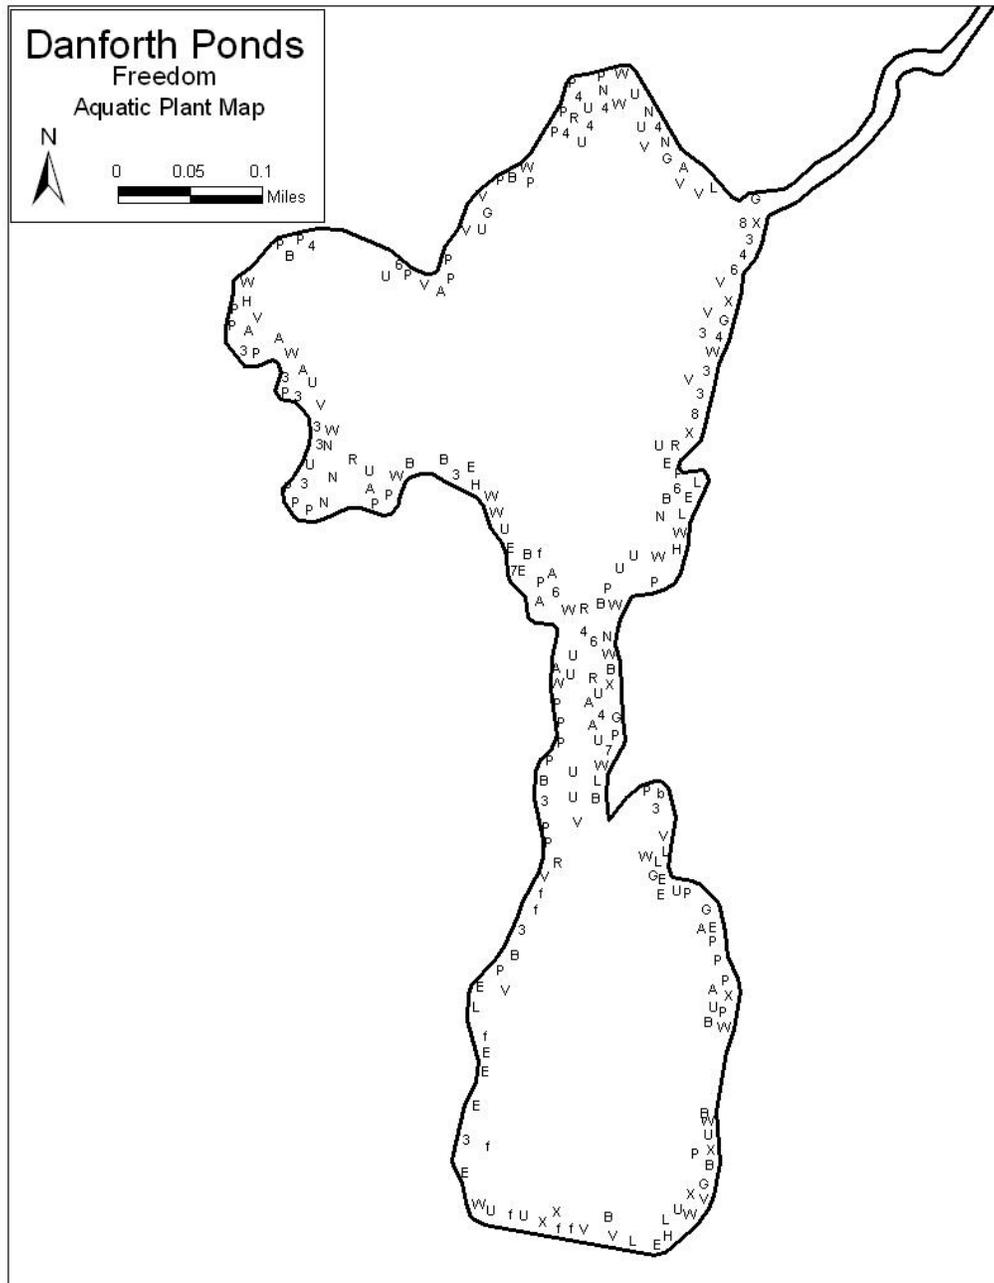
Figure 3: Map of Native Aquatic Macrophytes

A native aquatic vegetation map and key from an August 2009 survey (field checked annually, no updates needed) by the DES Biology Section is shown in Figure 3. A bathymetric map is shown in Figure 4.

The littoral zone of Danforth Ponds is characterized by a mix of native and non-native (variable milfoil, purple loosestrife) plant growth (Figure 3). Native species include a mix of floating plants (white and yellow water-lilies, floating heart, watershield), emergent plants (cattail, bur-reed, pipewort, water lobelia, grassy arrowhead, spike rush, pickerelweed, arrowhead, swamp loosestrife, and three-way sedge), and submergent plants (water naiad, alternate-leaf milfoil, water marigold, hedge hyssop, tape-like bur-reed, various pondweeds, bladderwort, tape-grass, waterweed, grassy spike rush). Native plant communities are mixed around the entire lake, and are characterized as ‘scattered to common’ by the DES.

In addition to the variable milfoil in the pond, the only other invasive aquatic plant that was observed was purple loosestrife, which was scattered in small areas around the shoreline of the ponds (see Figure 3 for locations).
