# Long-Term Variable Milfoil Management Plan

*Danforth Pond System  
Freedom, New Hampshire*

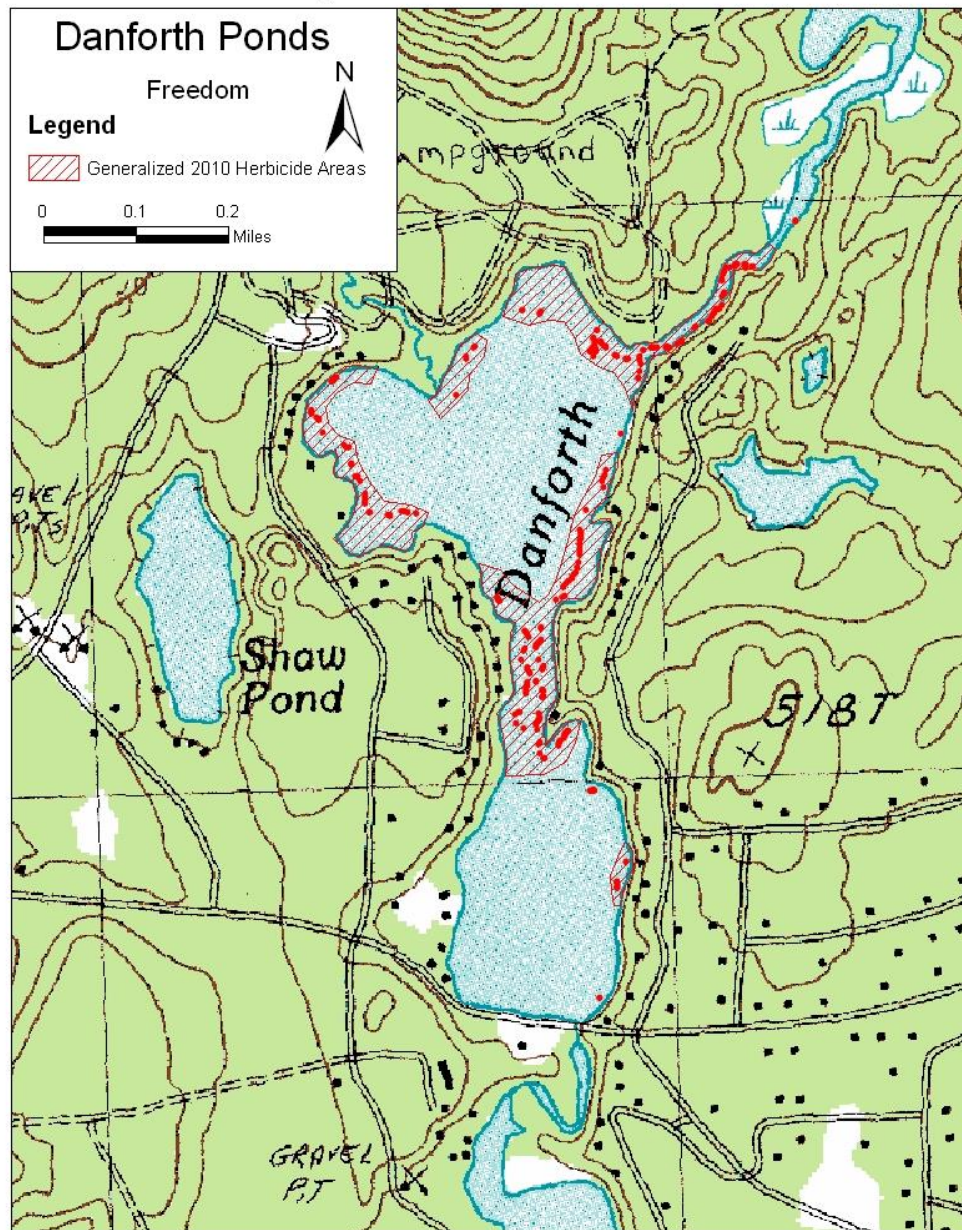
2010

Figure 2: Map of Control Actions Over Time

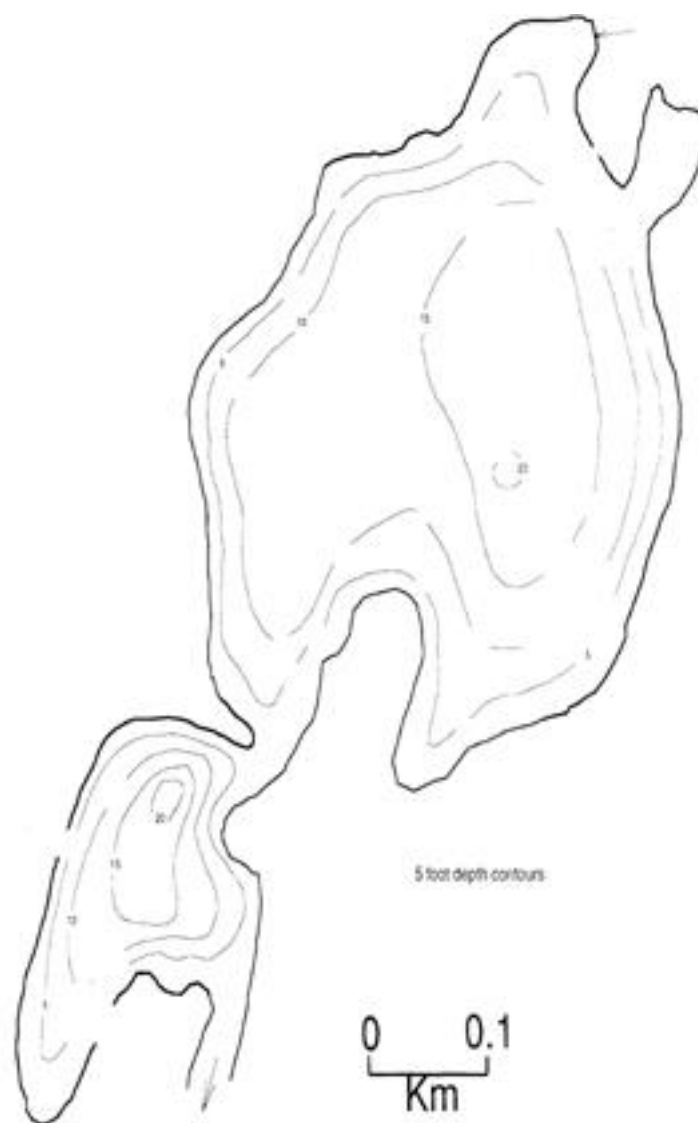
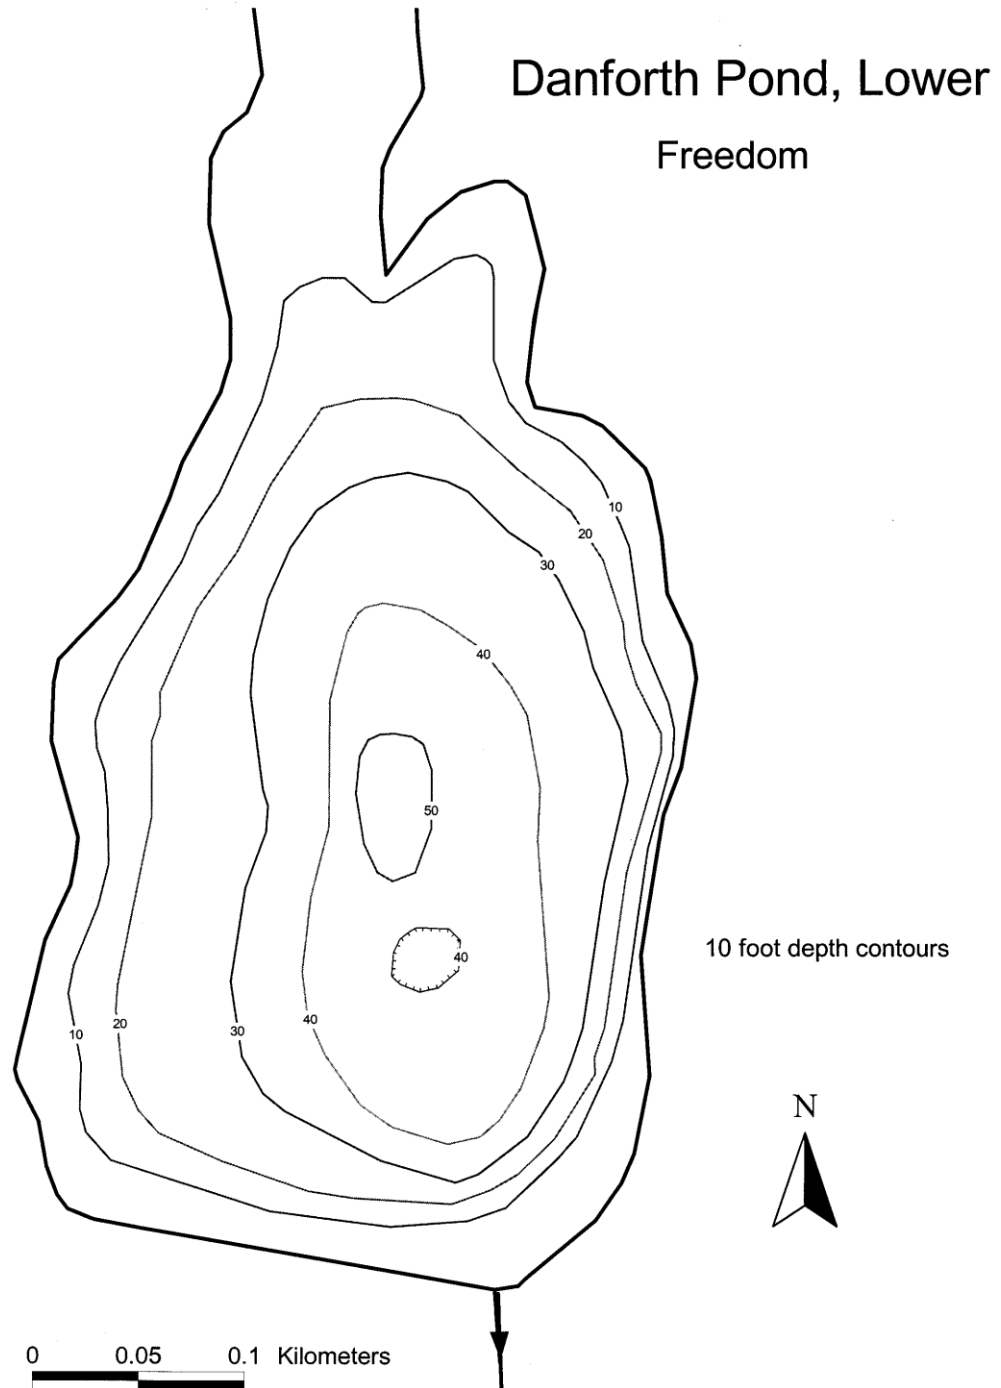
**Figure 4: Bathymetric Map**

A native aquatic vegetation map and key from an August 2009 survey (field checked annually, no updates needed) by the DES Biology Section is shown in Figure 3. A bathymetric map is shown in Figure 4.
