Town of Freedom

Town Office Feasibility Study

Masonic Temple & Town Office

29 & 33 Old Portland Road

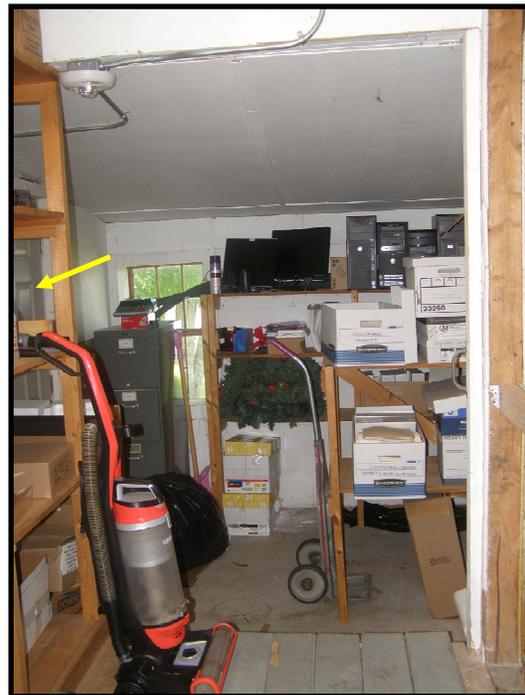
Storage/mechanical space at rear addition. Exit door is at left indicated by yellow arrow. Oil-fired furnace is located just to the right of this photo.

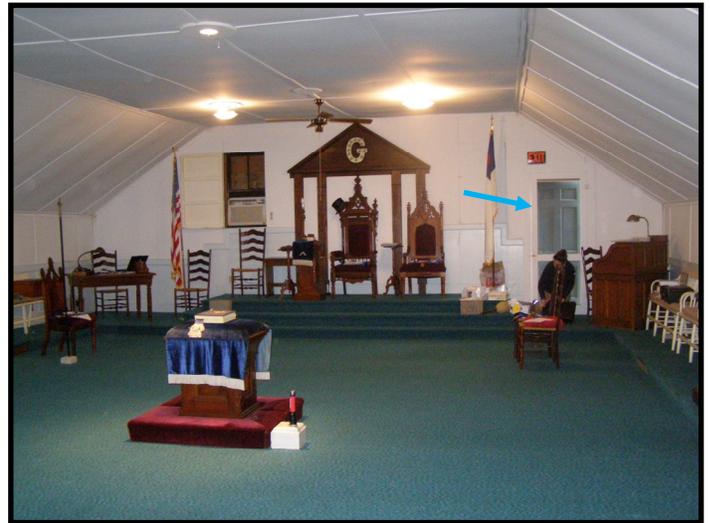
Masonic Temple looking north. Emergency exit door leading to exterior metal fire escape indicated with blue arrow.

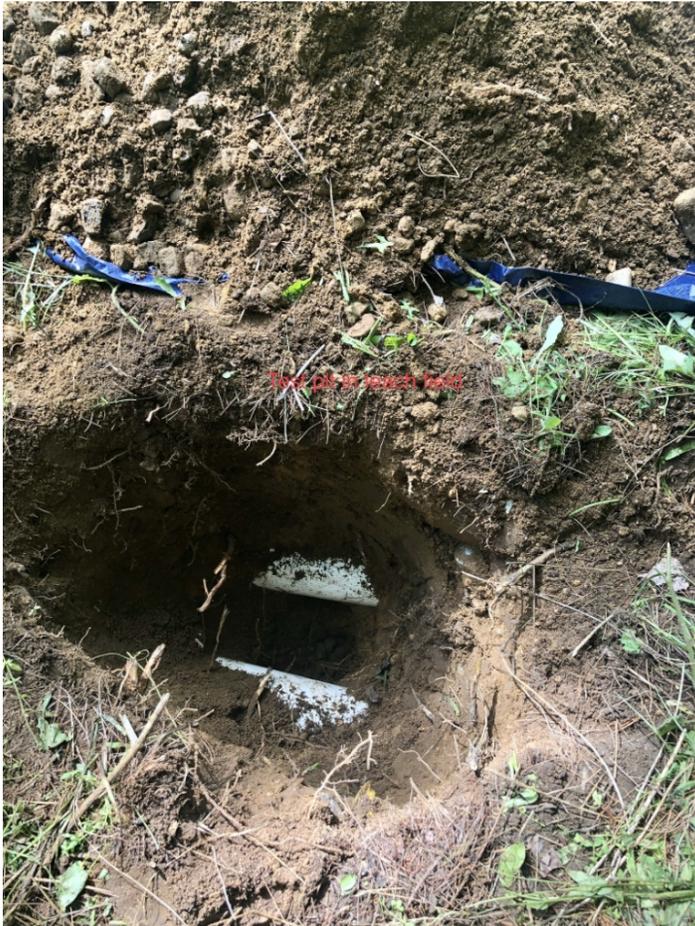
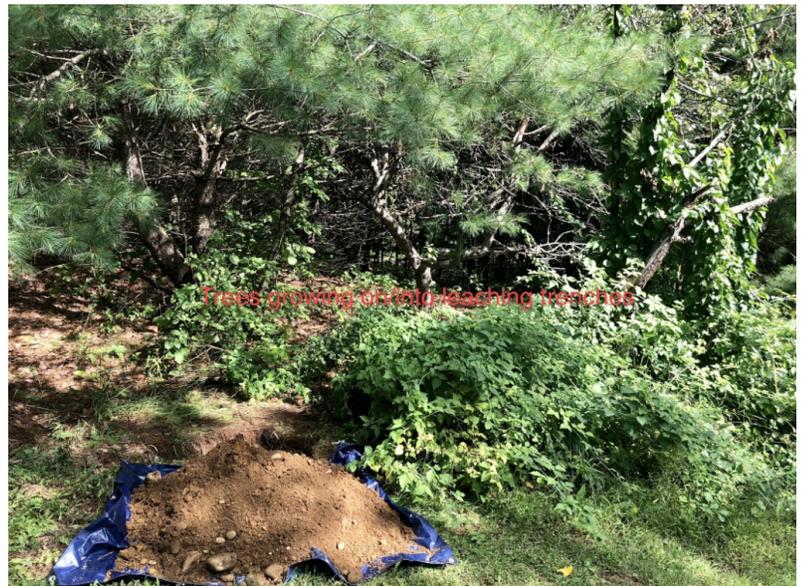
Type of field stone and pipe trenches
Disposal field located yes
Size of field in square feet 42'x25' approximately
Condition of Field leach field was dry, with appropriate signs of use for its age
grown trees present in/above leach field

septic system appears in working condition. septic tank was pumped prior to inspection, so system could not be loaded for perc test.

trees in/above leach field should be removed, and Root Kill applied
